# Application of Digital Radiography to Weld Inspection for the Space Shuttle External Fuel Tank

**Warren Ussery**  
Lockheed Martin Space Systems Company  
[warren.ussery@maf.nasa.gov](mailto:warren.ussery@maf.nasa.gov)  
504-257-1834

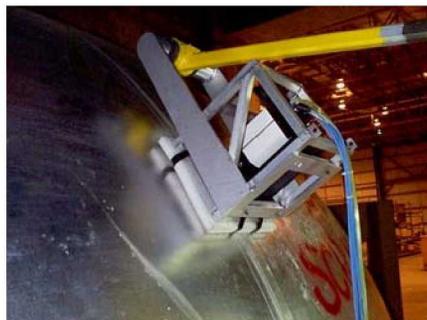
Detection of small cracks

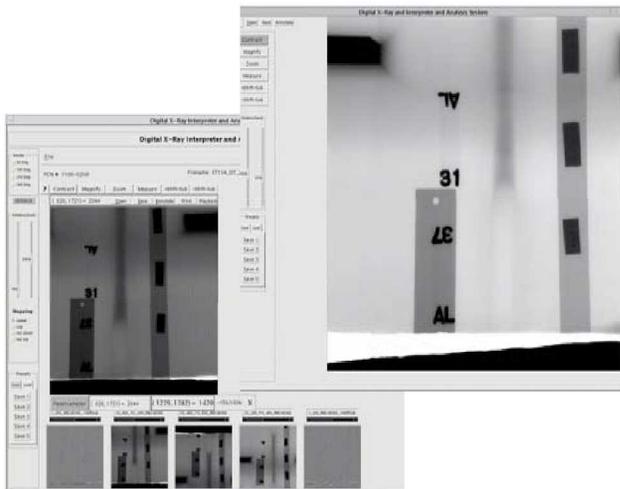
Customized software operates on a series of images

- **Computer literate personnel with film interpretation experience are a plus**
- **Automated tooling speeds acquisition and produces repeatable data**
- **Integration of IQIs into tooling design**
- **Customized interpretation software improves efficiency**
  - All imaging tools available
  - Required tools applied automatically
  - Automatic +15% / -30% penetrameter calculation
  - Playback controls simulate film spool operations
